NATIONAL BUREAU OF STANDARDS

CIRCULAR OF THE BUREAU OF STANDARDS C450

UNDERGROUND CORROSION

By Kirk H. Logan

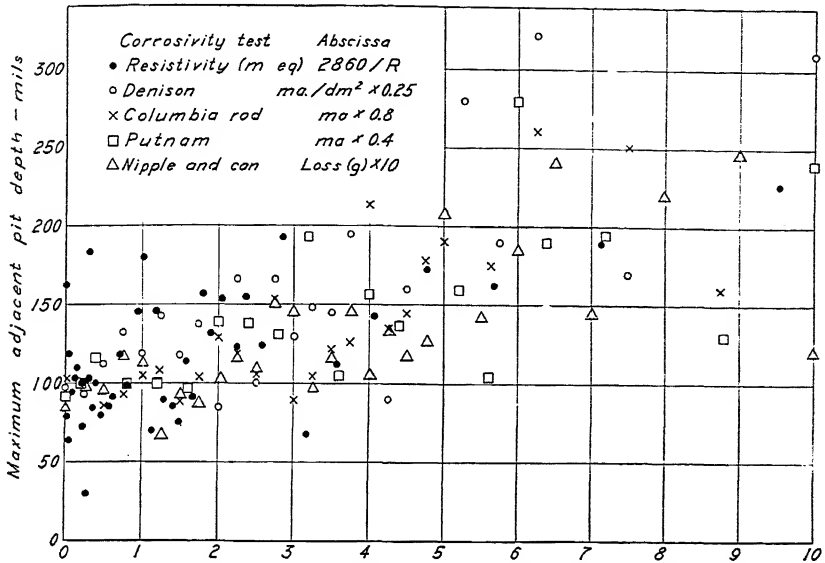
FIGURE 65.—Comparison of corrosivity of soil as indicated by the maximum pit depths on sections of pipe adjacent to places where soil samples were taken with results of various soil tests.

See key at top of illustration for units for the abscissa.

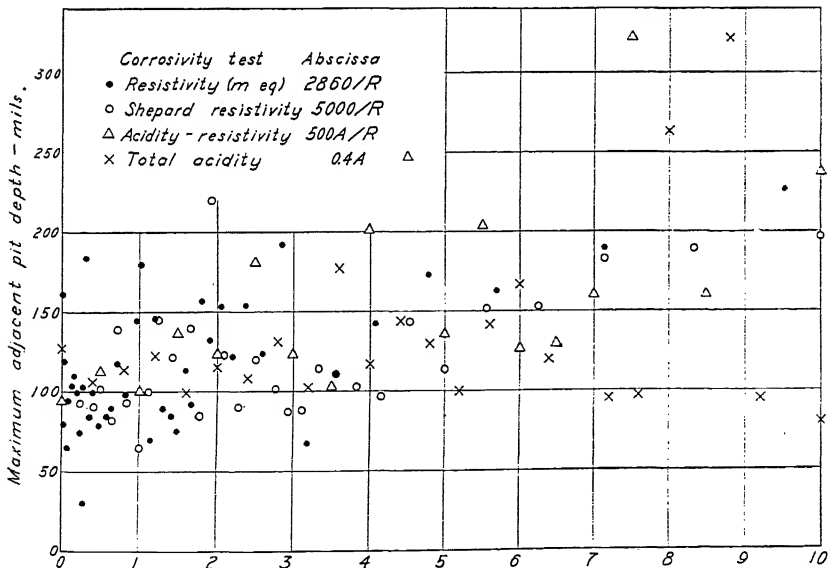
FIGURE 66.—Comparison of corrosivity of soil as indicated by the maximum pit depths on sections of pipe adjacent to places at which soil samples were taken with results of various soil tests.

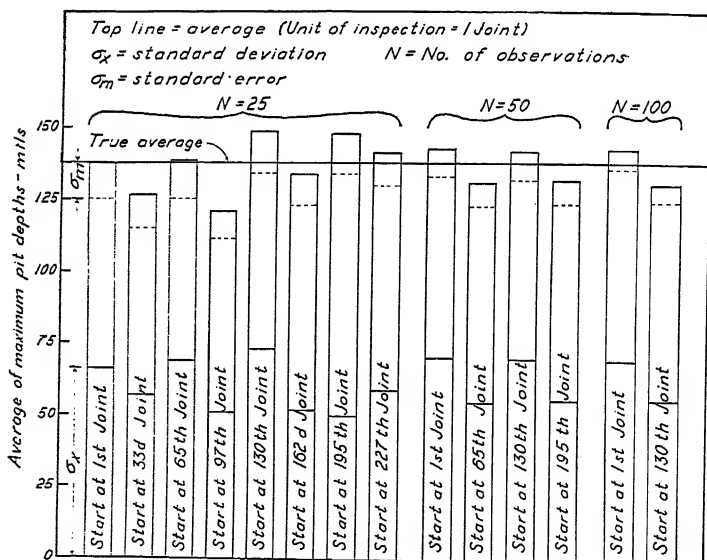
FIGURE 67.—Effect of the starting point and the number of inspections on the observed average of maximum pit depths on sections of a pipe line.

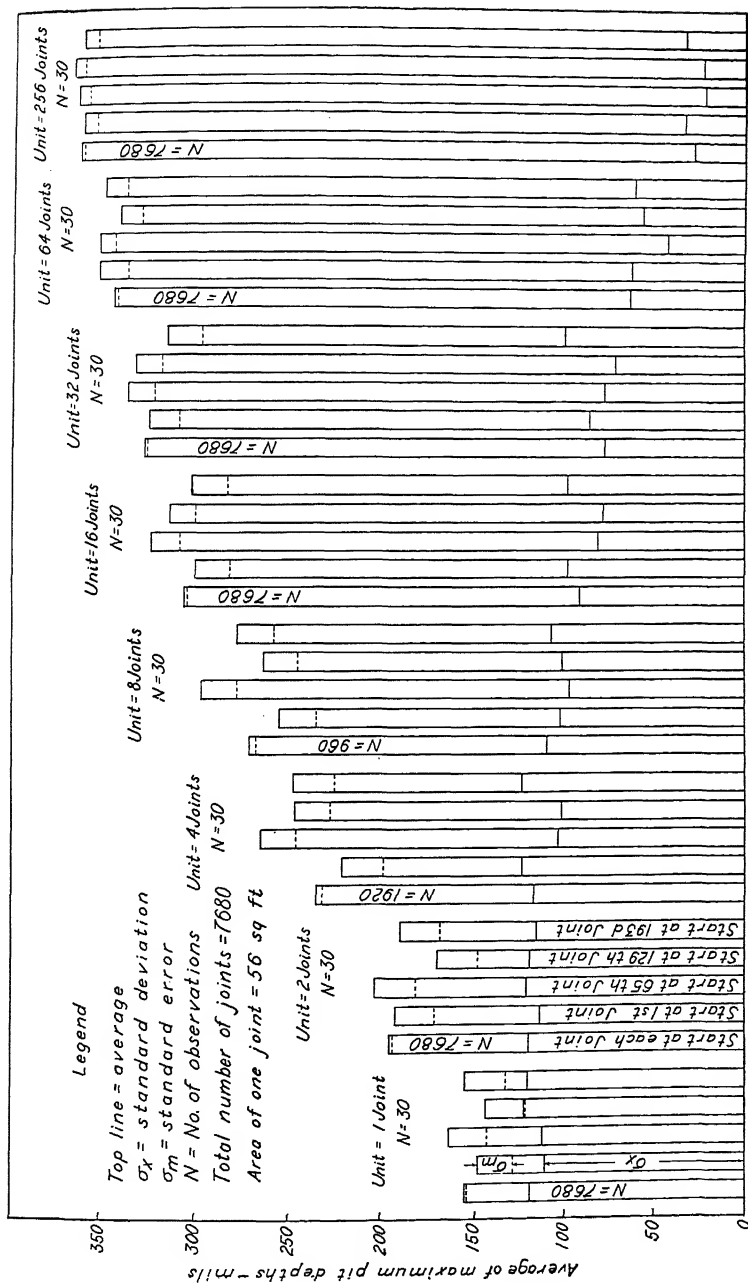
FIGURE 68.—Effect of the point at which inspections were started and the area inspected on the computed average of the maximum pit depths.

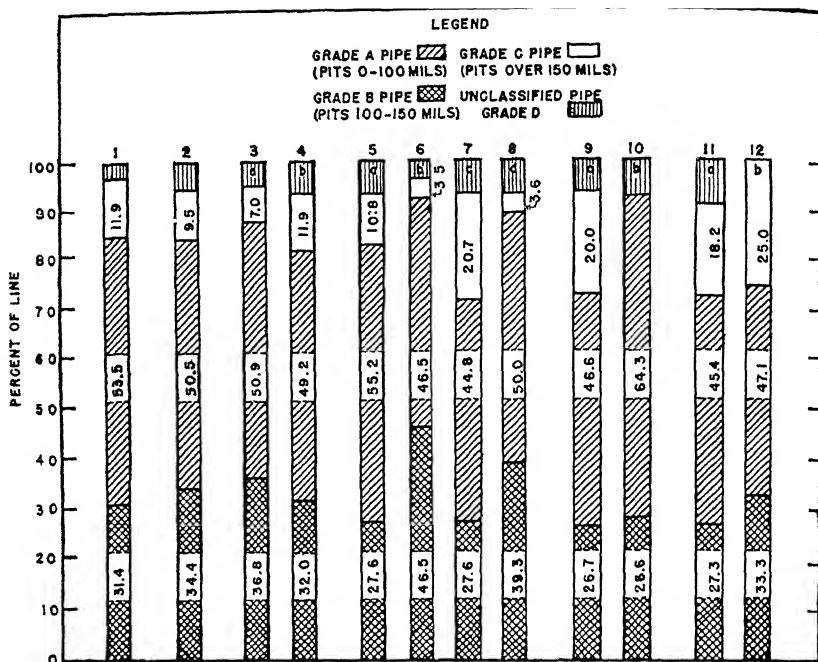
FIGURE 69.—Effect of method of inspection on apparent condition of a pipe line.

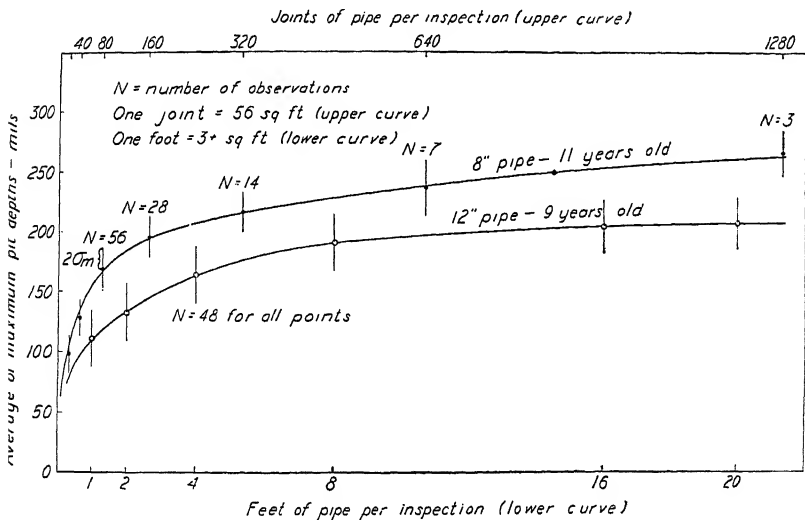
FIGURE 70.—Relation of area of pipe inspected to the maximum pit depths on each area.

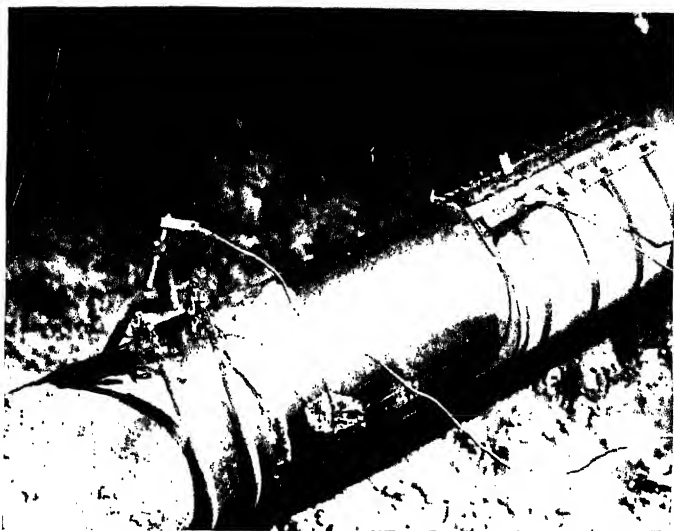
FIGURE 71.—Setup for making pattern and resistance tests of pipe coatings.

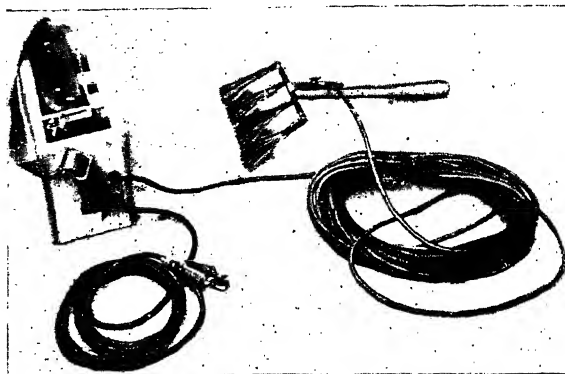
FIGURE 72.—Apparatus for locating pinholes in bituminous coatings.

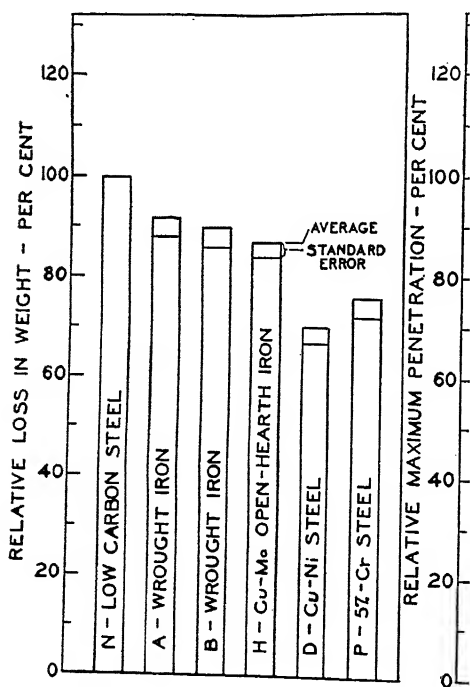
FIGURE 74.—Relative loss of weight and penetration of wrought ferrous specimens. Low carbon steel=100 percent.

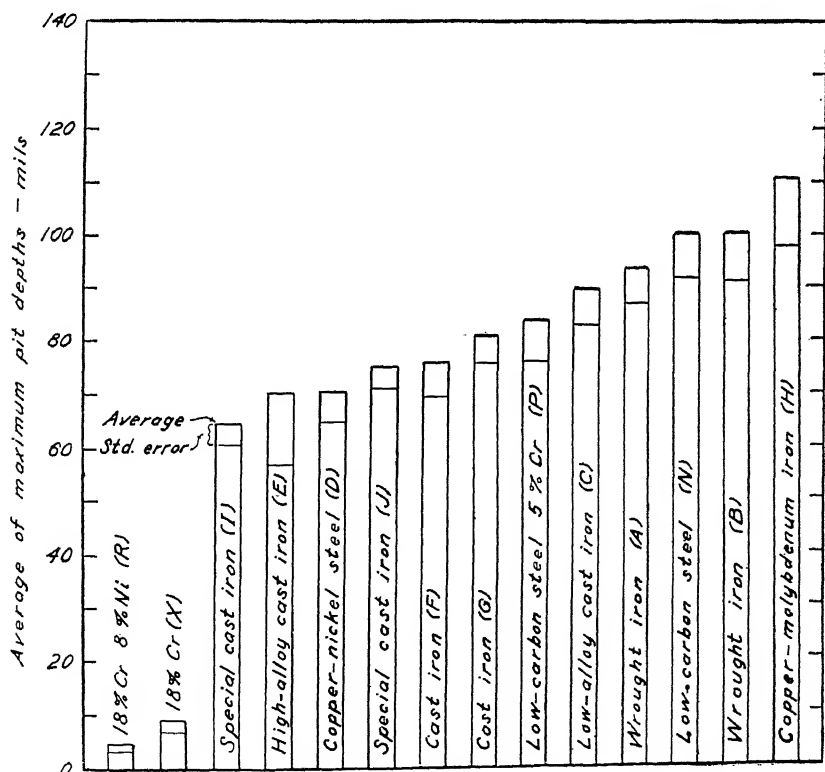
FIGURE 75.—Average of maximum pit depths on ferrous pipes removed from Merced clay adobe after an exposure of 5 years.

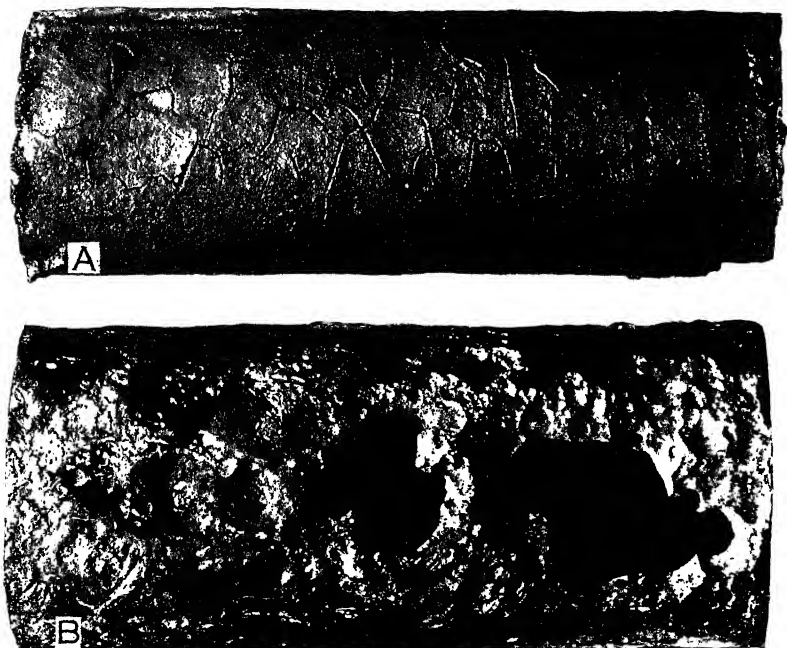
FIGURE 76.—Examples of failure of pipe coatings.

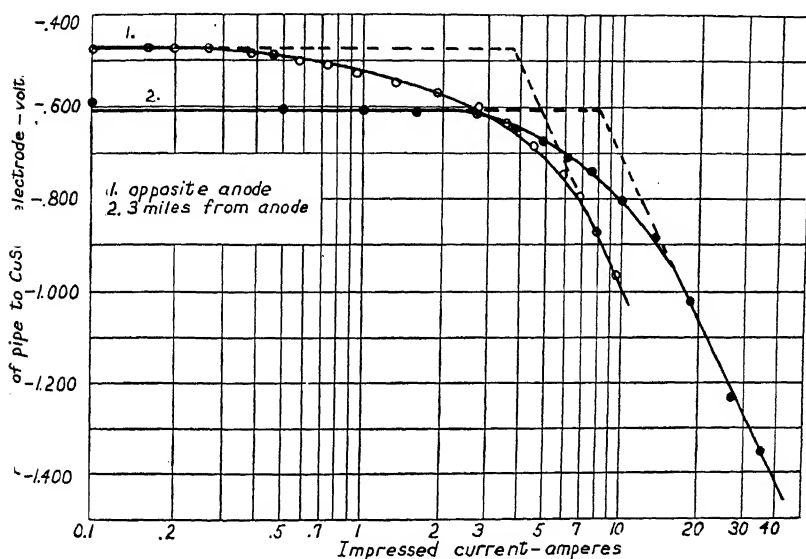
FIGURE 77.—Current-potential curves for 6-inch pipe.

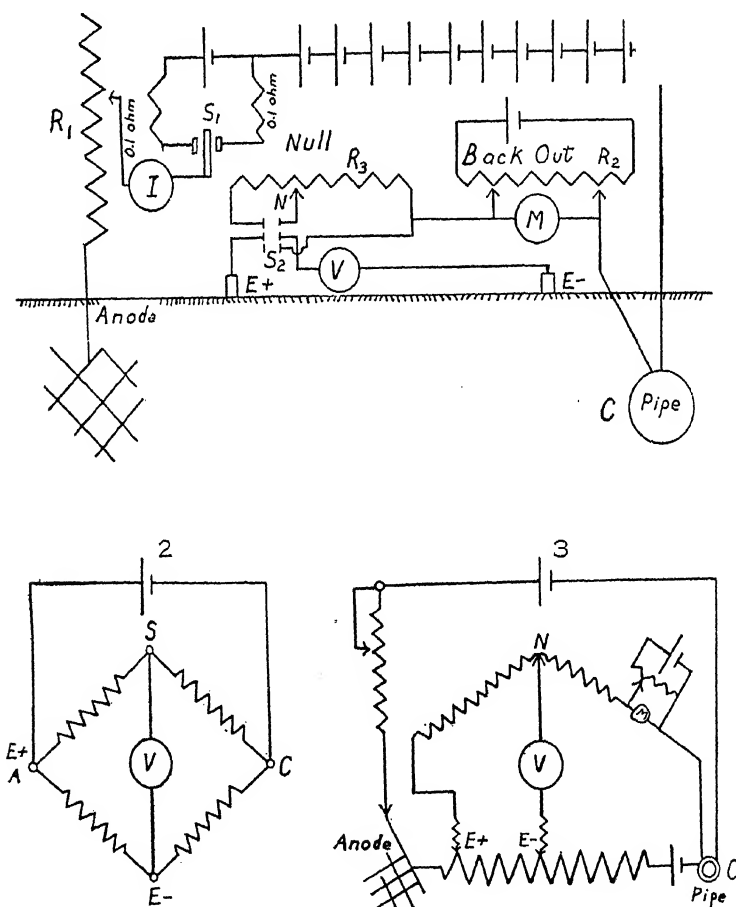
FIGURE 78.—Pearson-Hadley null current.

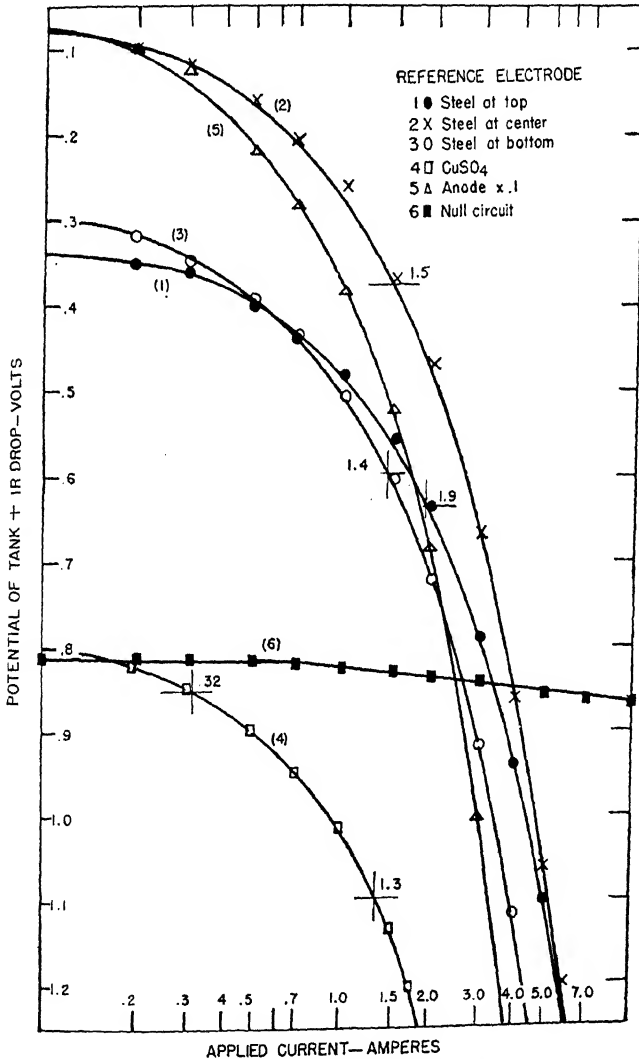
FIGURE 79.—Current-potential curves for a buried tank.

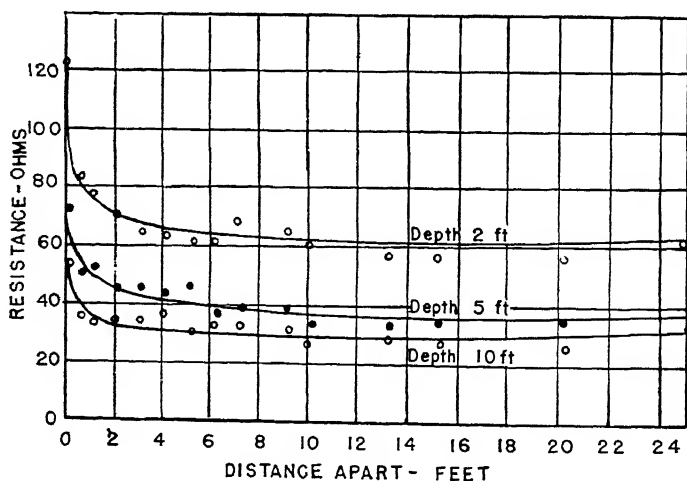
FIGURE 83.—Effect of the distance apart of two driven-pipe grounds in parallel on their resistance to earth.

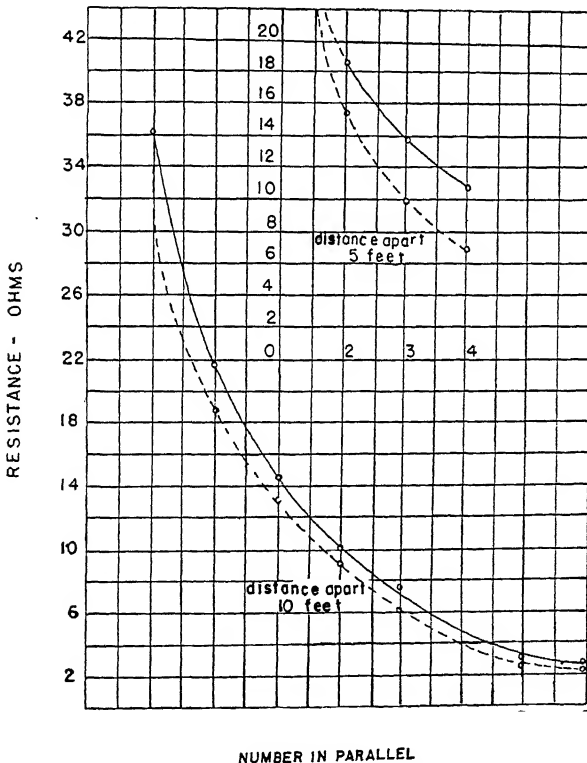
FIGURE 84.—Effect of the number of 10-foot driven-pipe grounds in parallel on their resistance to earth.

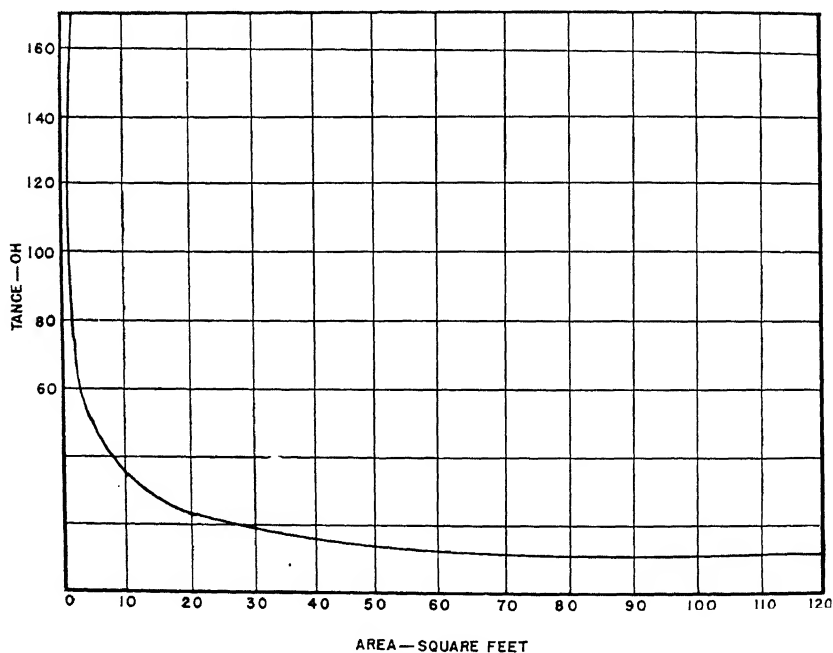
FIGURE 85.—Effect of the diameter of a buried circular plate on its resistance to ground.

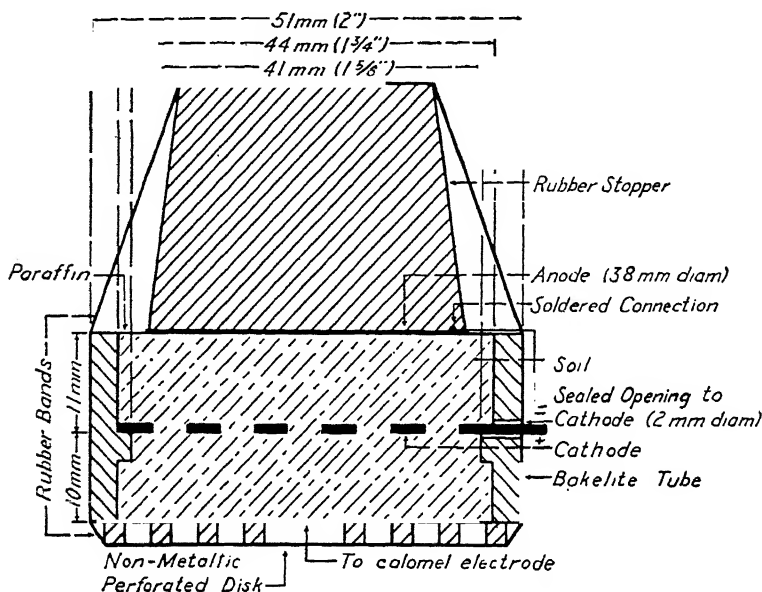
FIGURE 87.—Denison corrosion cell.
